# HAZARD ALERT

## WORKER KILLED IN ROCK CRUSHER EXPLOSION

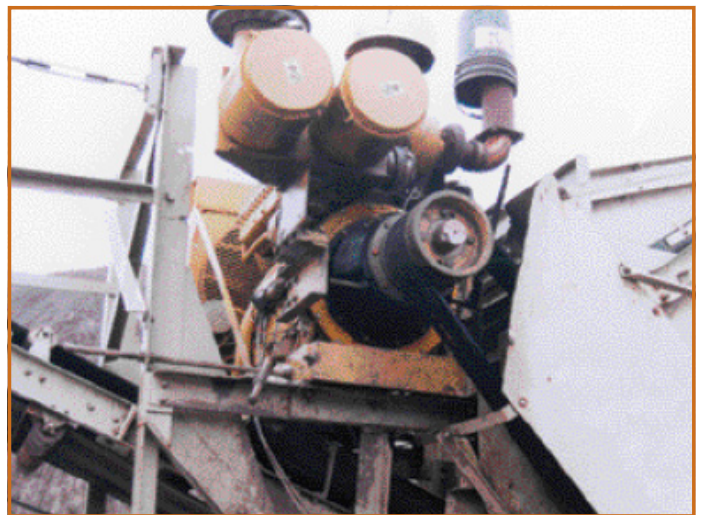
*Shortly after starting up the rock crusher for a day's production, the operator spotted smoke coming from the transmission housing. The operator immediately went to disengage the clutch and look for the source of the smoke. At that instant, the transmission blew apart with the debris causing a fatal wound. One 90-kilogram (200-pound) piece flew 5.5 metres (18 feet), striking a payloader.*

The WorkSafeNB investigation determined the crusher had been properly lubricated, with operational repairs made as required. However, maintenance records were not documented, nor was there a maintenance schedule.

The drive assembly typically requires 12 to 18 belts on the drive spool. For this, the supplier recommends belts for each position. Operators typically wait until it is necessary to replace an entire set of belts. To compensate for having fewer drive belts, operators must increase the tension on the remaining belts. This results in a condition known as "side loading." This condition increases the load on the clutch assembly, potentially causing the seal to leak and create excessive wear on the clutch, leading to overheating. Should the bearing lose lubrication fully, the result is an explosive disintegration of the transmission.

1. Schedule maintenance (such as all lubrication and bearing inspections), track hours of operation, and above all document all the work (lubrication by type and location, repairs made, alterations, etc.).
2. Apply the proper tension to the drive belts as per manufacturer's specifications.
3. Match the capacity of the drive unit to that of the clutch assembly.
4. Follow all supplier recommended preventive maintenance schedules.
5. Do not exceed manufacturer's recommended limits for side-pull loading.
