MOBILE CRANE BRAKE FAILURE LEADS TO NEAR MISS

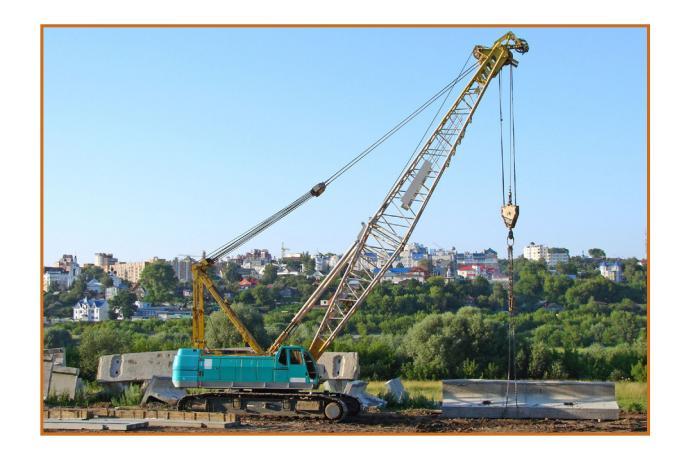
A 125-ton capacity mobile crane was lifting a 60-foot, 25-ton beam off a trailer to place on an abutment. The crane operator had no problems during the lifting sequence's first two movements. After booming down, he brought the controls back to neutral. The brakes did not engage as expected and the load fell to the ground. No workers were injured during this incident.

Employers, owners and mobile crane operators need to be vigilant when using a hoisting apparatus equipped with band-on-drum type brakes. Possible causes of brake failure include:

Temperature: A significant drop in temperature can cause slight shrinkage of the brake band. When clearance tolerances are set too low, any shrinkage could cause the parts to seize.

Moisture: Excess moisture on the brake drum can cause the brake to slip. Also, any moisture between the lever and pin can freeze in cold temperatures, causing the brake to slip.

Corrosion: Corrosion on the mating faces can build up and cause interference.

Lubrication: Due to the lever's minimal movement, any grease applied from the fitting would have difficulty lubricating the full circumference of the pin, as per manufacturers' design specification.

Brake lining wear: Adjustments on the brakes need to be verified periodically based on the crane's usage. Even wear of 0.002" on the brake lining can compound the effects of the lack of movement on the lever.

- When conducting preventive maintenance on equipment, remove the pin at the end of the rod and rotate to confirm free movement. This allows the lever to be verified for free movement, without disturbing the brake band adjustments.
- Groove the lever's internal surface to allow for better grease distribution. The manufacturer must design and approve any crane modification.

- Install a grease line to a location where the fitting is easier to access. Precaution must be taken against over-greasing. Again, the manufacturer must approve any modification.
- Install an air dryer on the pneumatic system to prevent the possibility of condensation building up in air lines during cold weather operation.
- Silicone can be used to seal any openings that may have let moisture into the system.
- Brake covers can be modified to make them easily and quickly accessible, to check for moisture during adverse conditions.
- Contact crane manufacturers periodically (every six months, for example) for unit updates, upgrades or modifications. An inquiry into recently recorded accidents or near misses is also suggested.
